DEPARTMENT OF TRANSPORTATION

Quality Assurance and Source Inspection

Contract #: 04-0120F4Cty: SF/ALA Rte: 80 PM: 13.2/13.9File #: 69.28**WELDING INSPECTION REPORT****Resident Engineer:**Siegenthaler, Peter**Address:** 333 Burma Road**City:** Oakland, CA 94607**Report No:** WIR-022079**Date Inspected:** 03-Jan-2011**Project Name:** SAS Superstructure**OSM Arrival Time:** 700**Prime Contractor:** American Bridge/Fluor Enterprises, a JV**OSM Departure Time:** 1900**Contractor:** Zhenhua Port Machinery Company, Ltd (ZPMC), Changxing Island **Location:** Shanghai, China**CWI Name:** An Qing Xiang**CWI Present:** Yes No**Inspected CWI report:** Yes No N/A**Rod Oven in Use:** Yes No N/A**Electrode to specification:** Yes No N/A**Weld Procedures Followed:** Yes No N/A**Qualified Welders:** Yes No N/A**Verified Joint Fit-up:** Yes No N/A**Approved Drawings:** Yes No N/A**Approved WPS:** Yes No N/A**Delayed / Cancelled:** Yes No N/A**Bridge No:** 34-0006**Component:** OBG**Summary of Items Observed:**

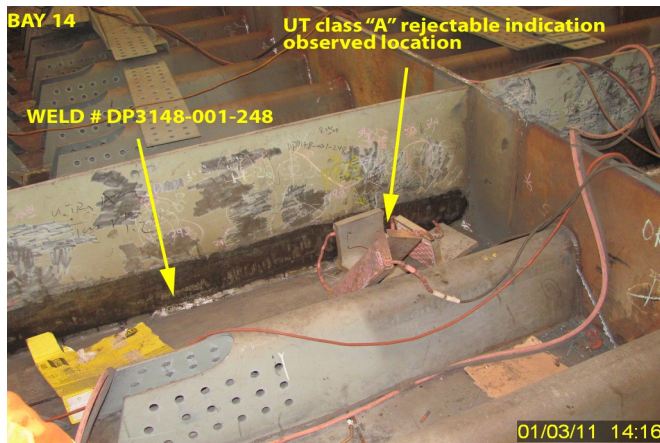
DP3148-001-248 (UT class "A" rejectable indication found during inspection)

During Ultrasonic Testing of weld joint DP3148-001-248, one class "A" UT rejectable indication observed and confirmed with ZPMC NDT personnel. This issue has been discussed with CT lead QA and as per discussion no Incident Report to be generated. ZPMC agreed to do repair as comply with contract documents. Attached photograph provide additional detail.
